Riparian forests and cattle management problems in Andean subtropical streams: in the search of water quality sustainability

Quiroga, P. A.¹; H. R. Fernández^{2*}; M. D. Sirombra¹; E. Domínguez²

Abstract — Quiroga, P. A.; H. R. Fernández; M. D. Sirombra; E. Domínguez. 2011. "Riparian forests and cattle management problems in Andean subtropical streams: in the search of water quality sustainability". *Lilloa* 48 (1). Subtropical Andes harbor the headwaters of three huge South American basins (Plata, Salí-Dulce and part of the Amazon). They are affected by numerous different human activities, many of them too complex to approach from punctual perspectives. It has been suggested that domestic cattle activities result in a set of direct and indirect impacts. Riverine landscapes in Andean subtropics are affected by the type of cattle management used. Here we present the observed changes in a river and its surrounding area, from a basin studied for ten years. We concluded that cows can be considered as landscape engineers of the riparian zone. The QBR-MR (a modification of the European River Quality Index) is proposed, to include the cattle impact on Mountain Riparian forests. A detail

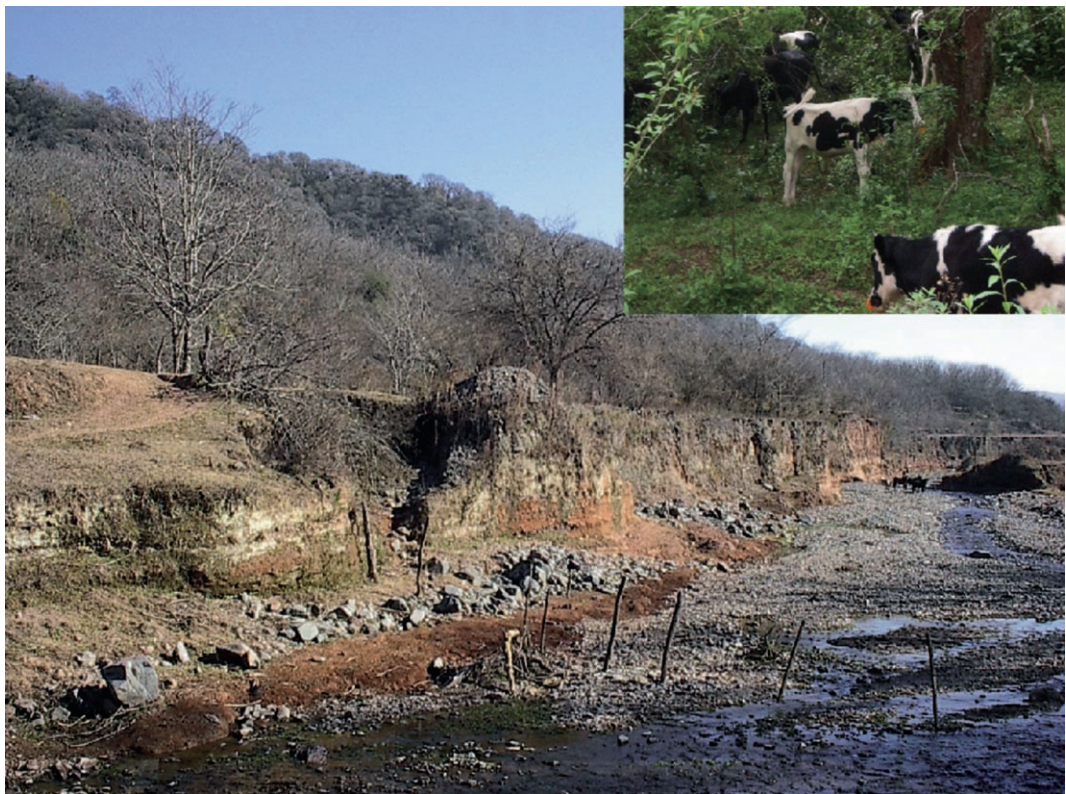
Fig. 2. Sampling site B in drought period showing a denuded and eroded soil. See a fence through the stream and some cows. On the terrace there is a grayish first line of *Gleditsia triacanthos* trees without leaf and behind is the subtropical mountain forest (Yungas). In the center - left can be observed an eroded track used in outdoor activities (mountain bikes and off-road motorcycles). Inset: The normal practice used in this region is to release the cattle in the forest. For vagrant cattle, the best possible area is in the vicinity of water courses, especially in drought period (April to October).

At the basins scale, Moyano and Movia (1988) described and classified vegetation from a physiognomic-structural point of view. They observed in this moment a low impact in forests and shrubs strata and some graze impact in the herbaceous strata, in upper creek areas, lower than 15° of slope. Riparian forests are still conserved in other upper zones, however cattle impact may be observed because they graze and search for water (Fig. 2). Native forests are also affect-

Most impacted station presents livestock fences creating a continuous grazing and do not allow vegetation recovery. Heavy grazing was observed in riverine geomorphology as deteriorated aspects such as much eroded banks, denuded soil, etc. (Fig. 2).

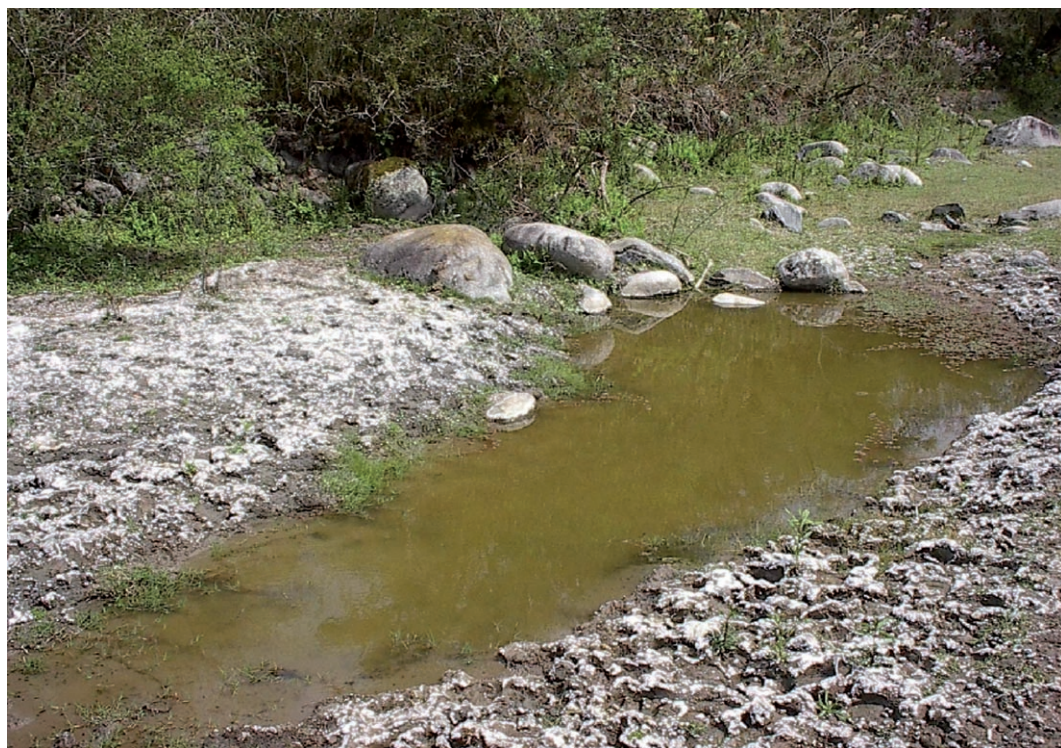
Fig. 3. Small natural sources of water in the lateral corridors of San Javier Stream. The small swamps developed around of them are frequently impacted by cattle looking for salt depositions.

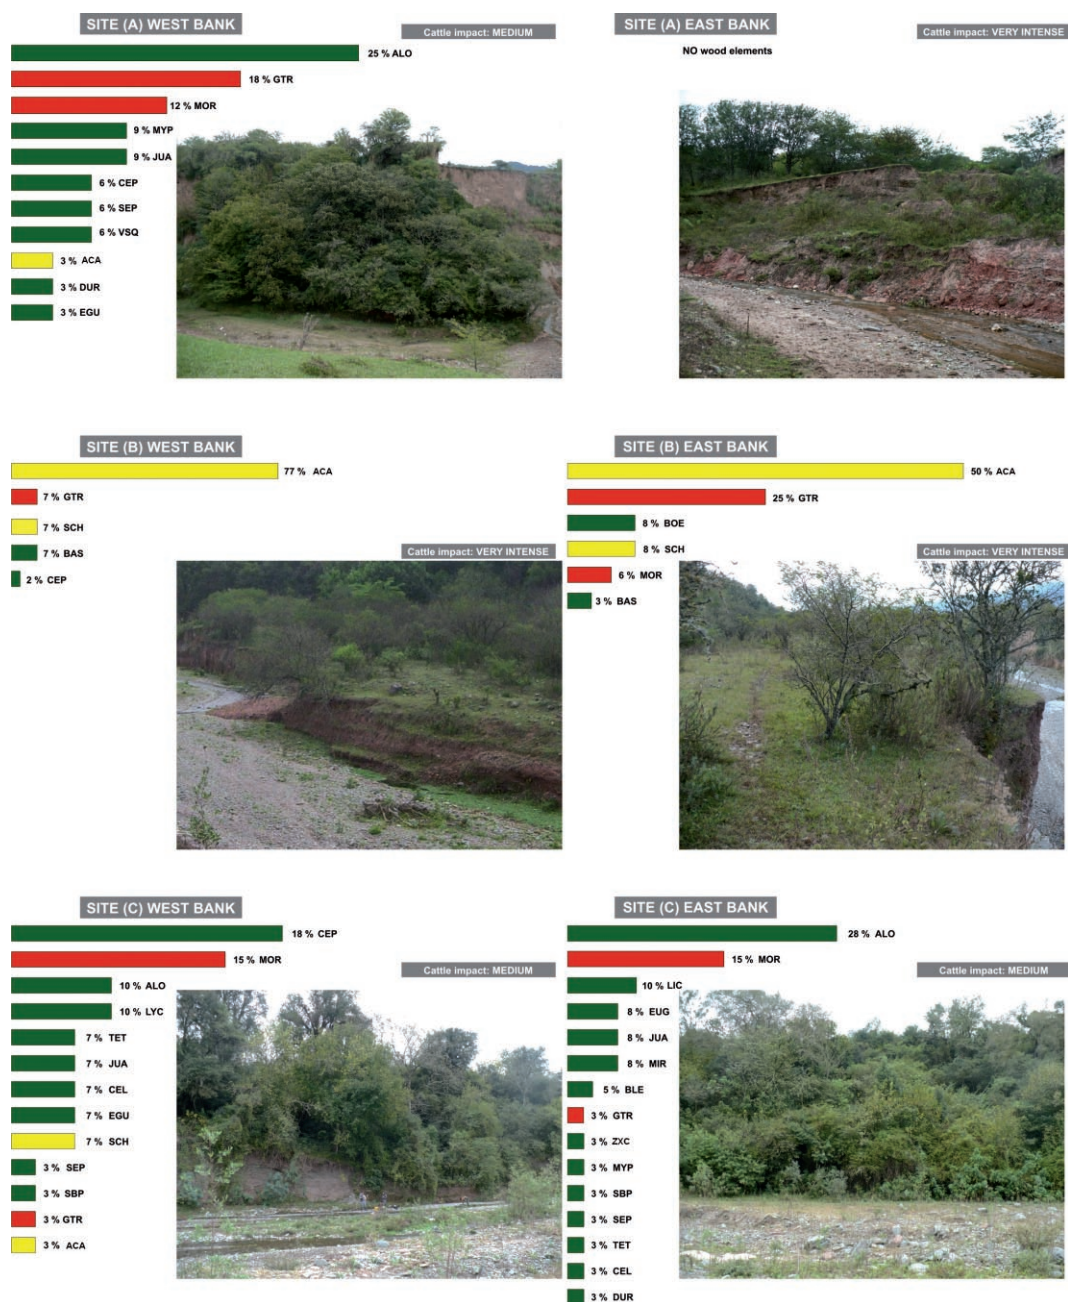
Figs. 4. and 5A. Species composition and relative importance in each site sampled. References: green: native species; yellow: native xerophyte species; red: exotic species. Species codes in Table 1.

The conditions of the riparian areas mentioned before are illustrated in Figs. 4 and 5A and the modified Riverine Quality Index for Mountain Rivers (QBR-MR) applied, in Fig. 5B. The Table 1 presents total species abundance and life form in each sampled site.

Exotic species presence was observed around the river corridors and terraces (Fig. 4 and 5A). In river corridors, small plants are observable but do not develop because annual floods periodically destroy them. One of the most important plants found in this basin is the introduced *Gleditsia triacanthos*. This spiny species from Florida (USA) is dispersed by cattle, showing an important adaptation capacity in NWA. Also, two other introduced spiny species *A. macracantha* (Tusca) and *Schinus bumeloides* are present in the riparian strip of San Javier Stream (Fig. 4, site B).

Vegetation changes observed around San Javier Stream show dryer characteristics than expected in this valley (yellow bars species in Fig. 4 and 5A). We attributed this to the presence of cattle, and probably an enclosure study would test this idea.

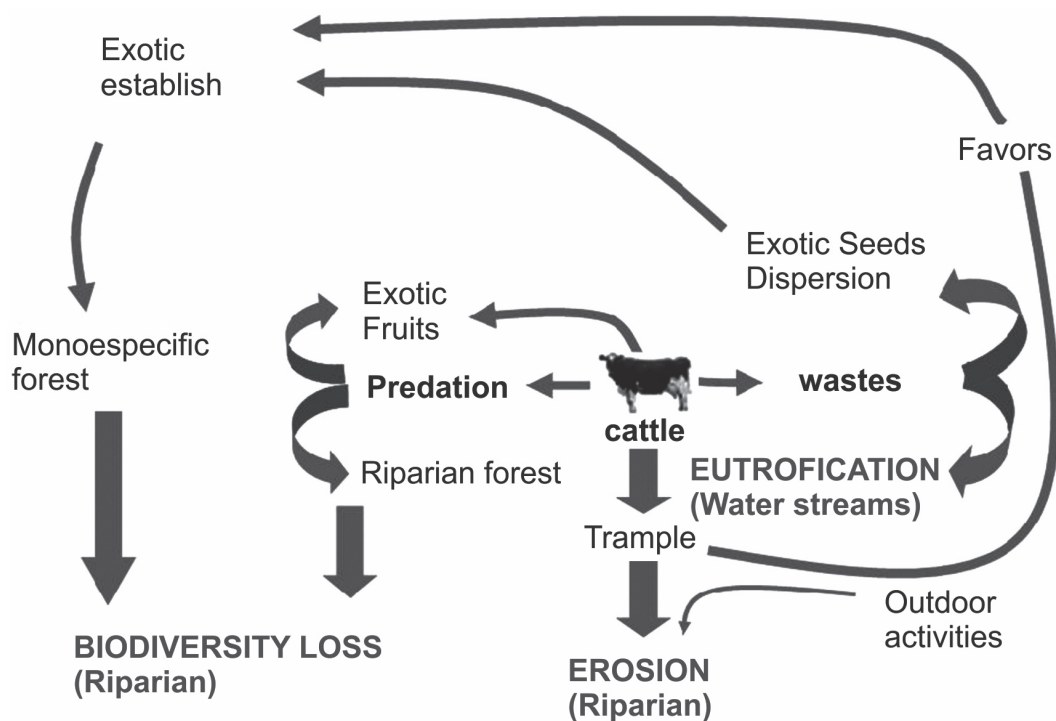
Fig. 7. Simplified model of peasants' cattle management effect produced in San Javier Basin, indicating the most important impacts.

Our observations are synthesized in a model around cattle impact in the riparian zone and the river, applicable to most of sub-tropical Andean basins (Fig. 7).
